PHOTOGRAPHS

PENNONI ASSOCIATES INC. 3001 MARKET STREET PHILADELPHIA, PENNSYLVANIA 19104 PHASE I ENVIRONMENTAL SITE ASSESSMENT

Former Philadelphia Gas Works Refueling Station North 9th Street and West Berks Street Philadelphia, Pennsylvania 19122

HAZARDOUS MATERIALS BUILDING SURVEY

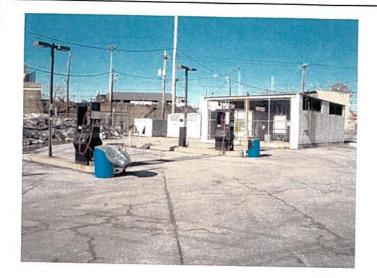
Photograph 1: View of the inactive compressed natural gas ("CNG") refueling station located in the northeast corner of the subject property. The masonry structure houses three (3) 48-inch inner diameter spherical CNG tanks, a compressor, a gas dryer, and a small control room. A second compressor, a 150-horespower compressor that replaced the compressor housed within the structure as the primary compressor in 1999, and an electrical switchgear box are located on a concrete pad on the northwest side of this structure. Two (2) CNG dispenser pump islands are located southwest of the structure. This refueling station was previously operated by PAF Fueling Systems, Inc., which refueled the CNG vehicle fleet previously operated by the Philadelphia Gas Works ("PGW").

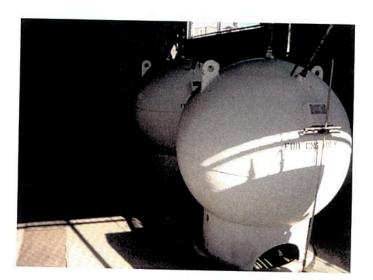
<u>Photograph 2:</u> View of the three (3) 48-inch inner diameter spherical CNG tanks located within the CNG refueling station structure. The tanks were observed to be in good condition.

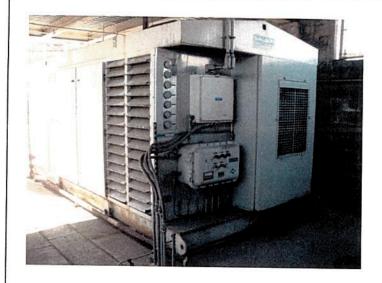
Photograph 4: View of the compressor located within the CNG refueling station structure.

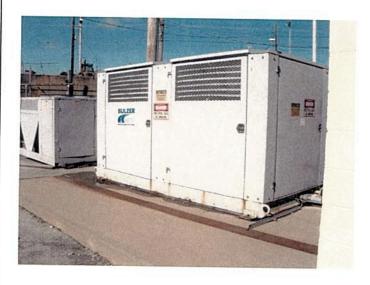
<u>Photograph 5:</u> View of the 150-horsepower compressor located on a concrete pad just outside the northwest corner of the CNG refueling station structure.

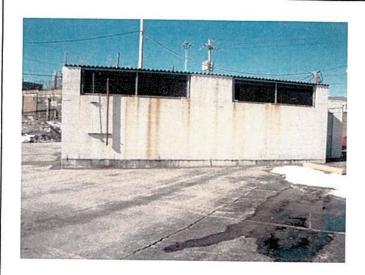
<u>Photograph 7:</u> View of the southeast side of the CNG refueling station structure.

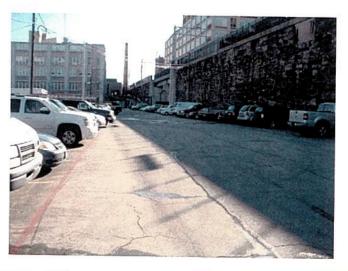
<u>Photograph 9:</u> View of the parking lot along the west side of the subject property. The Southeastern Pennsylvania Transportation Authority ("SEPTA") owns a right-of-way that extends 25 feet east of the stone retaining wall visible on the right in this photograph.

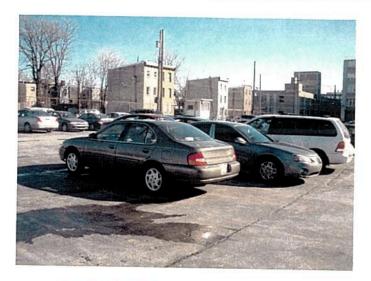
Photograph 10: View of the asphalt paved parking lot on the subject property.

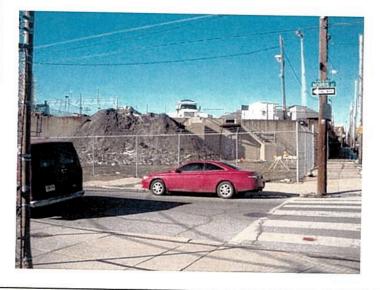
<u>Photograph 12:</u> View of a storage yard operated by PGW's Transportation Department located adjacent to the north of the subject property across West Norris Street.

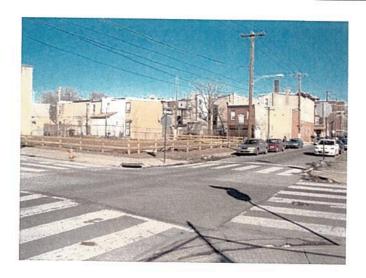
<u>Photograph 13:</u> View of a vacant lot and residential dwellings located adjacent to the northeast of the subject property across the intersection of West Norris Street and North 9th Street.

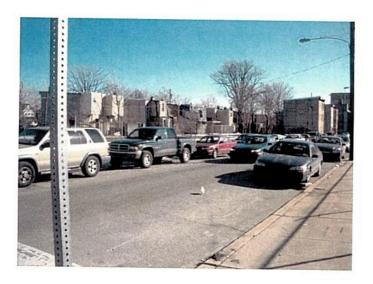
<u>Photograph 14:</u> View of vacant lots and residential dwellings located adjacent to the east of the subject property across North 9th Street.

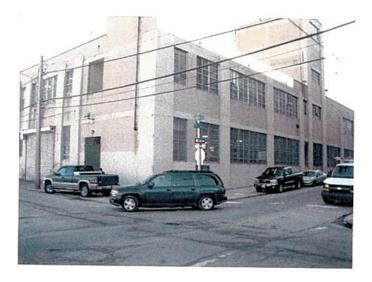
<u>Photograph 15:</u> View of PGW's Transportation Department garage located adjacent to the southeast of the subject property at the southeast corner of West Berks Street and North 9th Street.

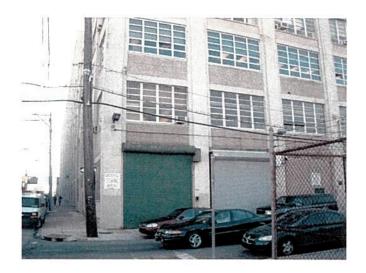
Photograph 16: View of the PGW office building and garage located adjacent to the south of the subject property across West Berks Street.

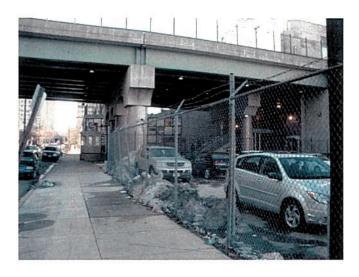
Photograph 17: View of the Temple University train station entrance and elevated lines of SEPTA's R-6 Regional Rail line located adjacent to the southwest corner f the subject property.
